DELL 3100 CN COLOR LASER PRINTER

DELL 3100 CN TONER CARTRIDGE

UNINET IMAGING INC. • DELL 3100 CN REMANUFACTURING INSTRUCTIONS

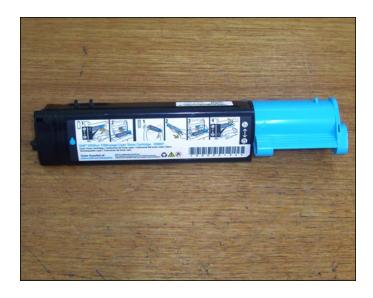
1. Disassembling the toner cartridge, starting from the lock position.

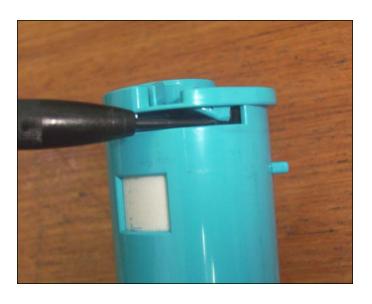
2. Use a small flat-head screwdriver to lift the tap over the stopper and allow you to turn the blue end piece counter-clockwise (color of end piece varies on color of cartridge).

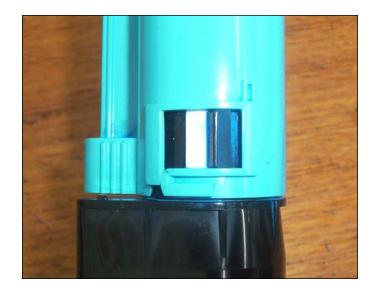
3. This is the starting point.

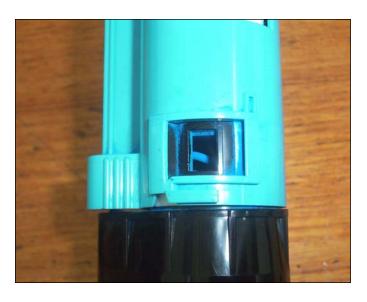
4. Turn the cap until the tab comes to a complete stop and has entered under the blue cap.

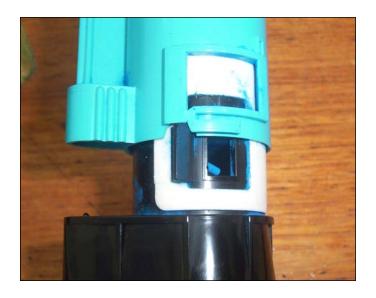
5. Now pull the cap, out away from the cartridge.

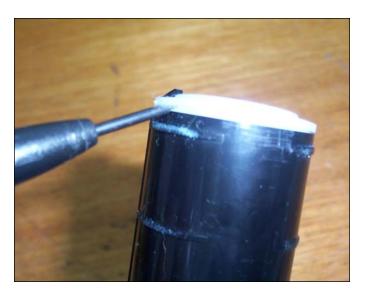
6. Remove the carrier fill plug.

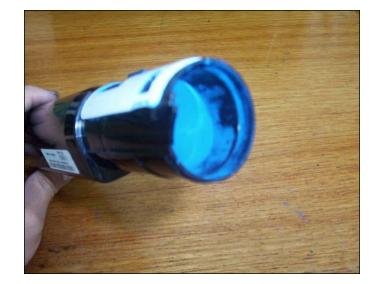
7. This is the carrier chamber, empty it out and you will find the toner fill plug. Remove it to clean cartridge and fill toner.
